CASE STUDY - CANNABIS GROW ROOM

This cannabis grow facility needed protection that would last indefinitely. The initial floor coatings which were simply concrete densifier and a clearcoat had already failed only months into production, the room needed to be coated properly to bring it up to compliance with Health & Drug departments.

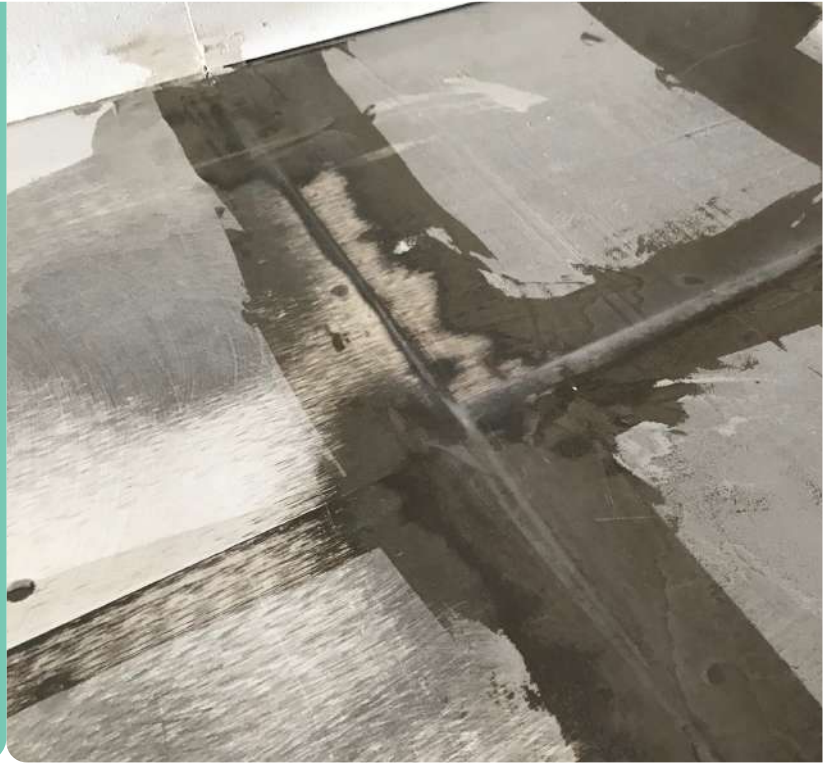
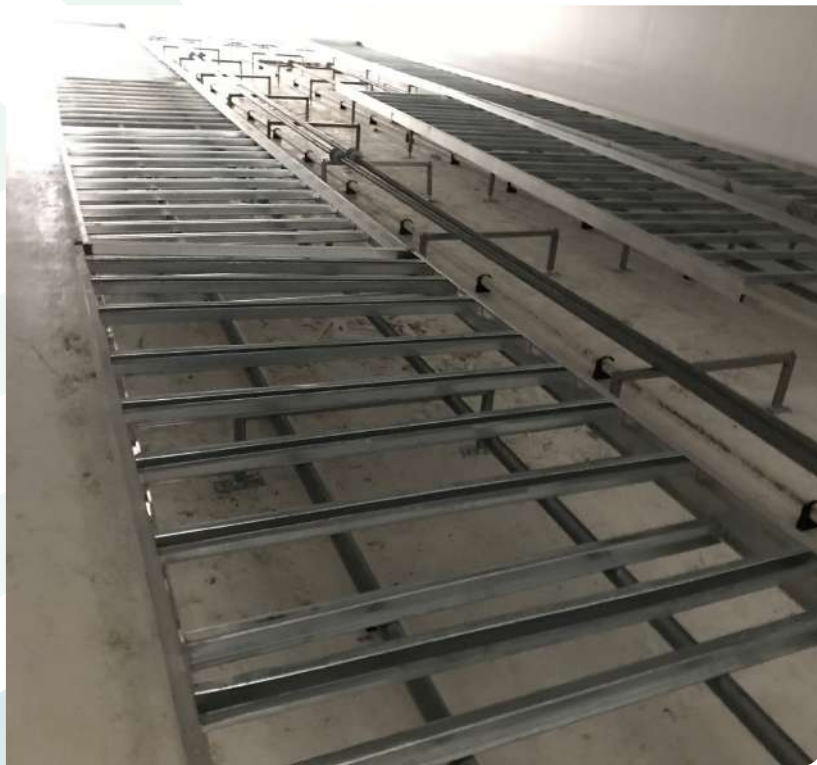
The racks had to be removed so that the job could be done properly. This allowed our installers easier access to the space and the ability to install the flooring faster.

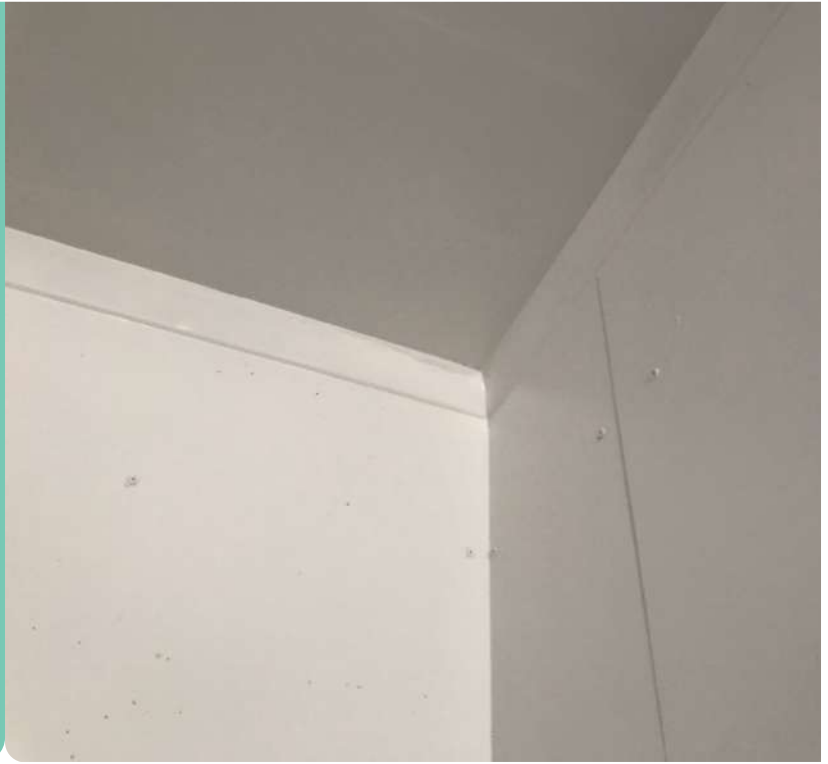
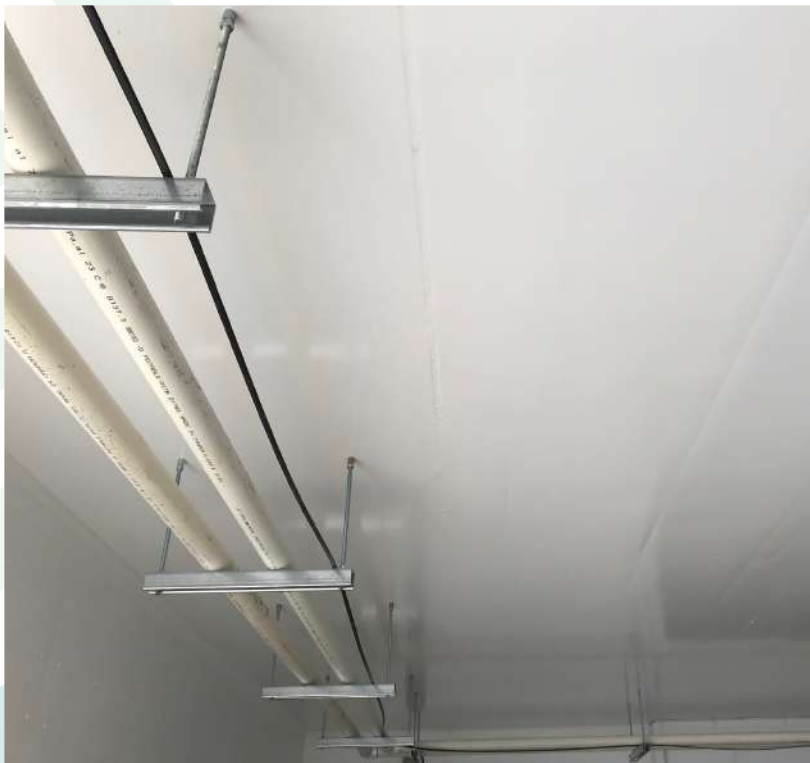
There were still voids prevalent in the wall and ceiling construction that would allow moisture to infiltrate in the form of screw holes and panel seams. These panels might look crisp and clean on the front-side after a wash; however, the problem happens behind the panel inside the wall itself. Spores of mould and bacteria can become airborne and affect the environment, staff, and products.

Any visible seams in the previously installed FRP panels needed to be filled with polyurethane and then coated over.

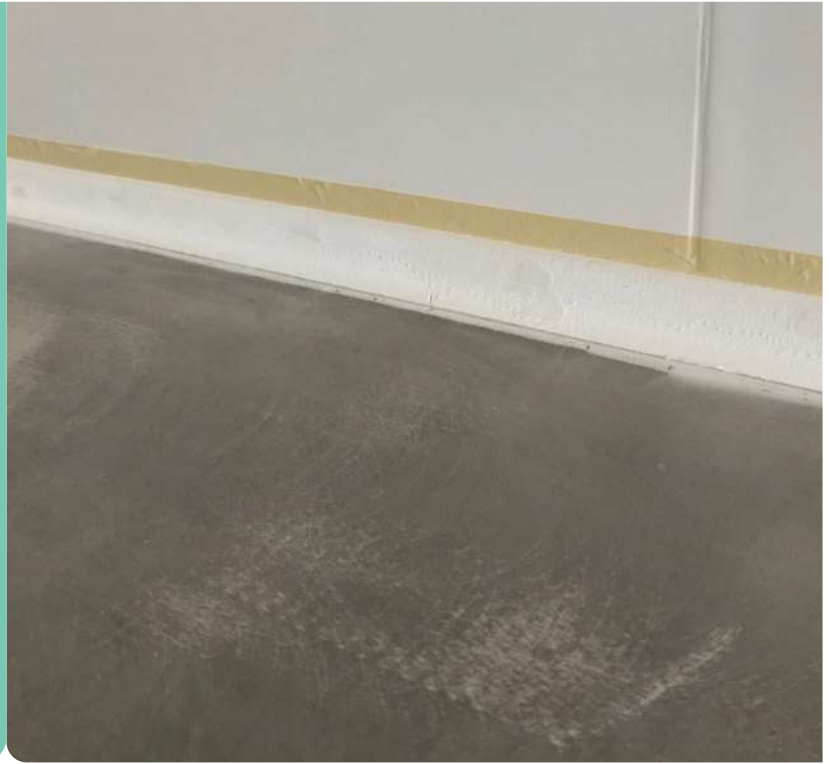
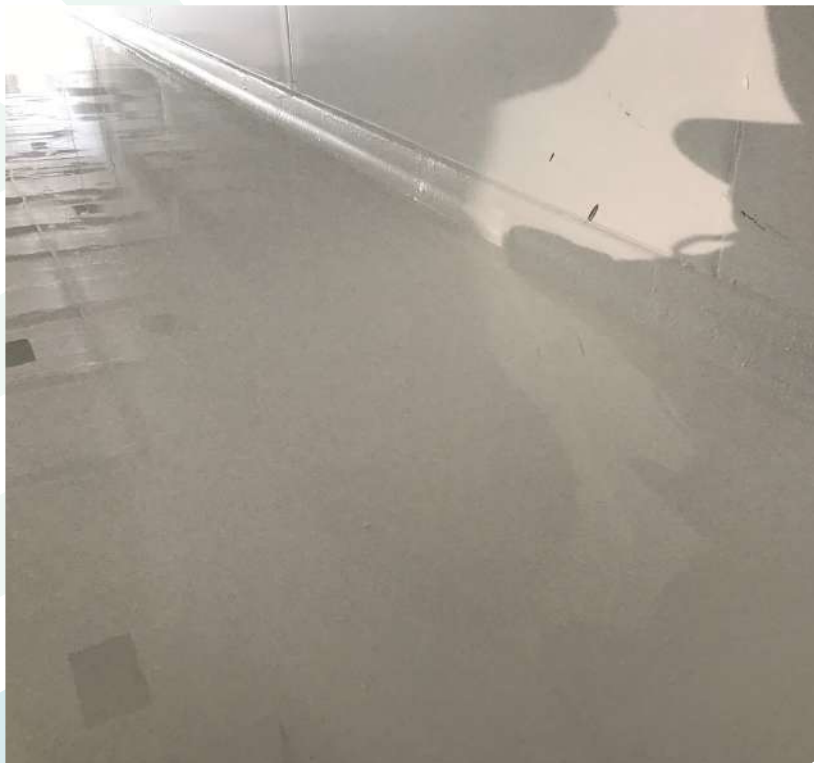
It was decided that we would carry the floor coating 4 inches up the wall and build a cove for the client to eliminate any possible seam or hard edge where the floor met the walls.

The first coatings were applied in order to remove any kind of visible seams from the rooms. This tied the walls into the floor creating one layer of protection over the entire space.

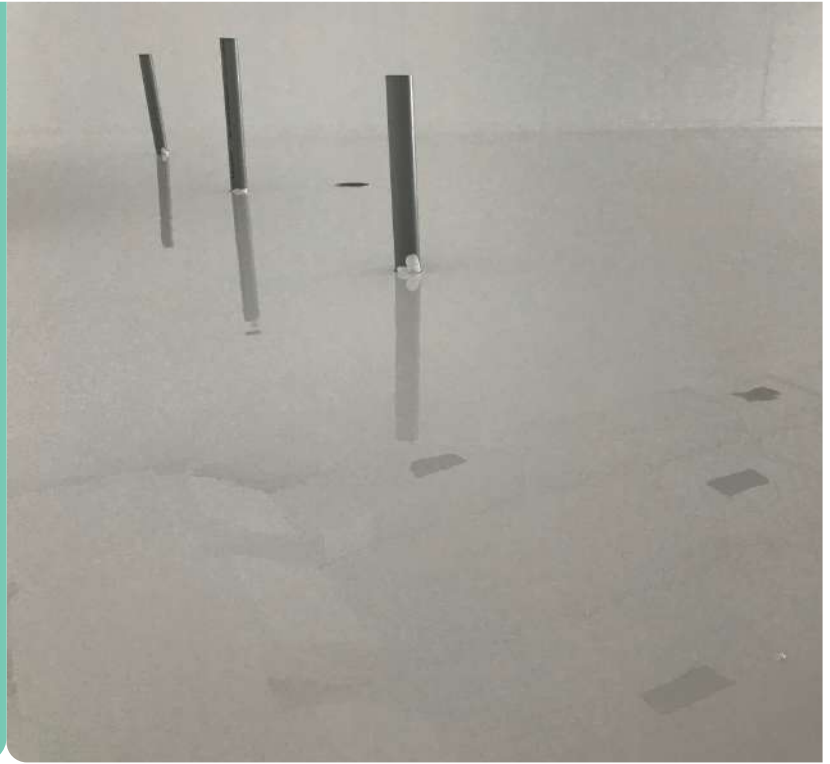
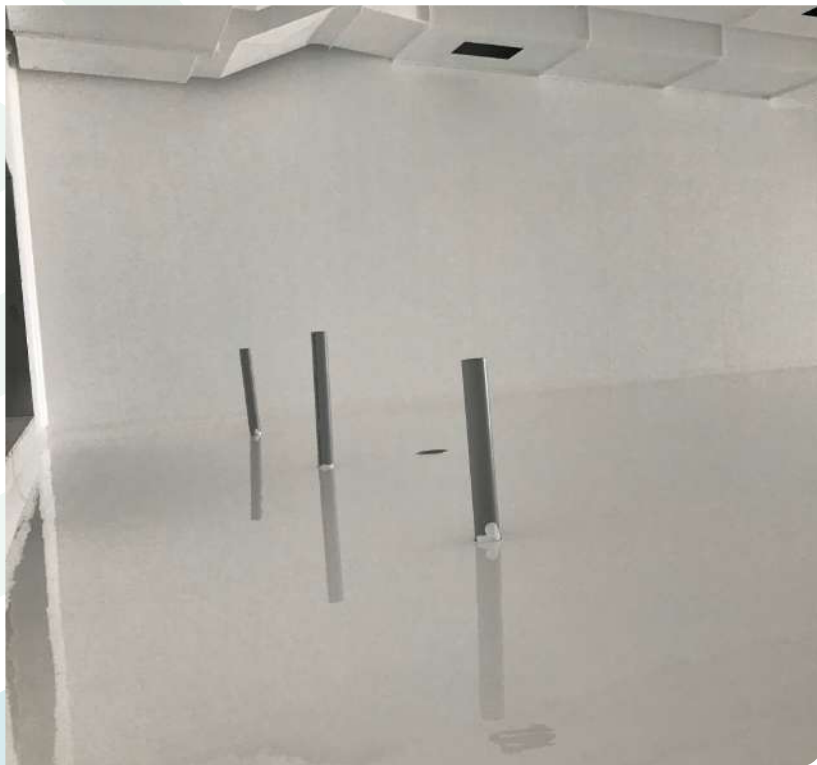
The floors as well as the walls needed to be highly reflective in order to reflect light back into the room and onto the client's product. This saved the client money on electrical costs that are spent to operate such a high demand operation.

Even the air ducts and ventilation controls were incorporated into the room with the coatings to maximize light savings and to seal every possible space and void that moisture, removing any space where bacteria or mould could hide.

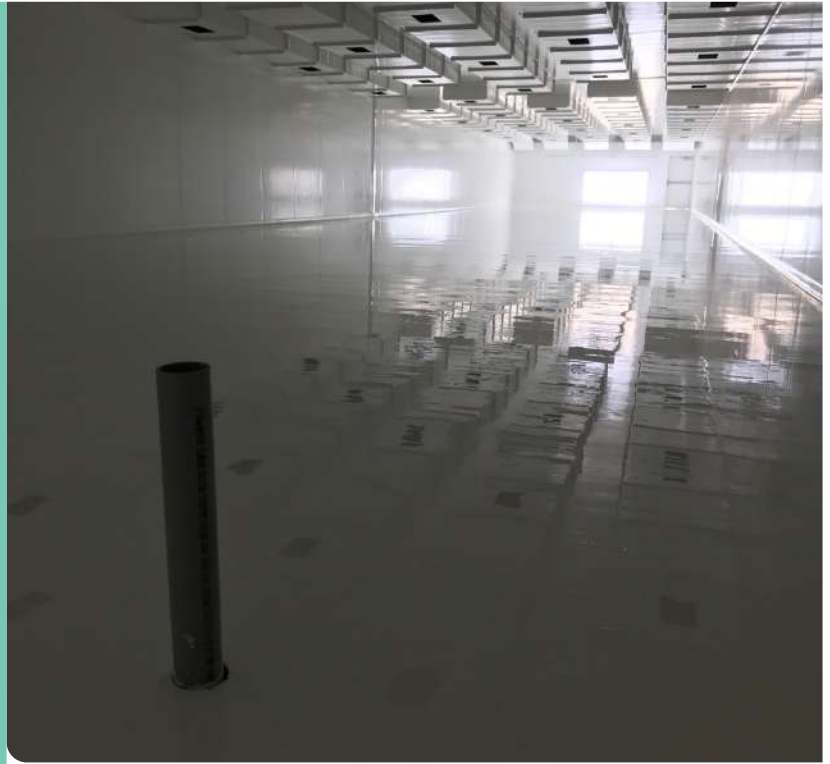
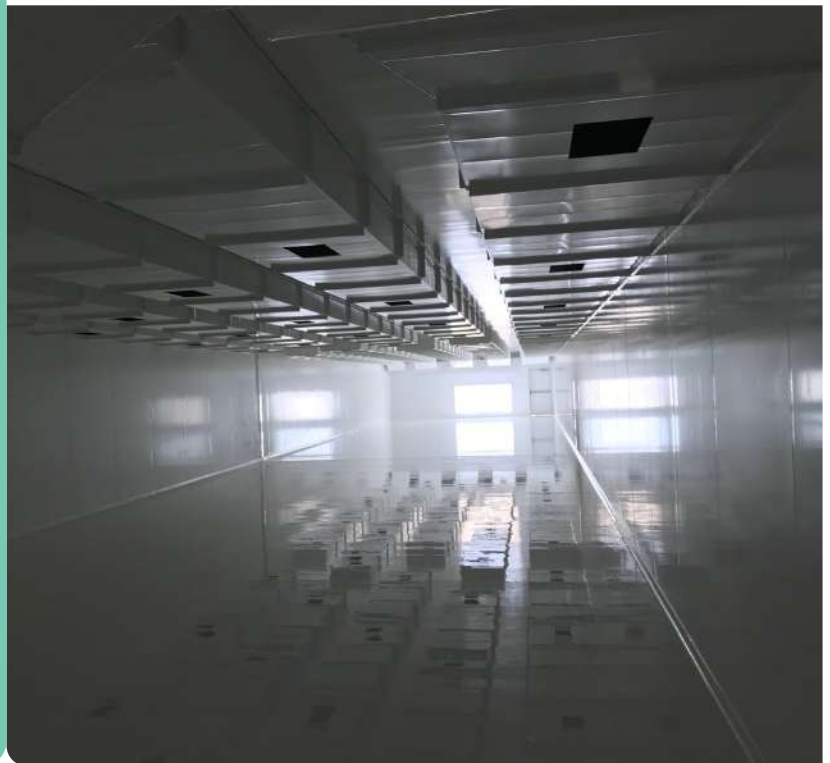
Now that the room is fully encapsulated, the client has an impenetrable surface that can be safely washed with pressure and cleaners. The final high gloss clear-coat was used to go on top the membrane layers of the walls, as a final protective layer of highly durable "armour" encased the entire room.

Now, this facility can be easily maintained and cleaned for years of growth cycles, meeting all the compliance standards in both Canada and the United States.
